## Testing of Joramark BOX300 according to ETAG 022 Annex F

**Assignment** Testing of Joramark BOX300 according to ETAG 022 Annex F

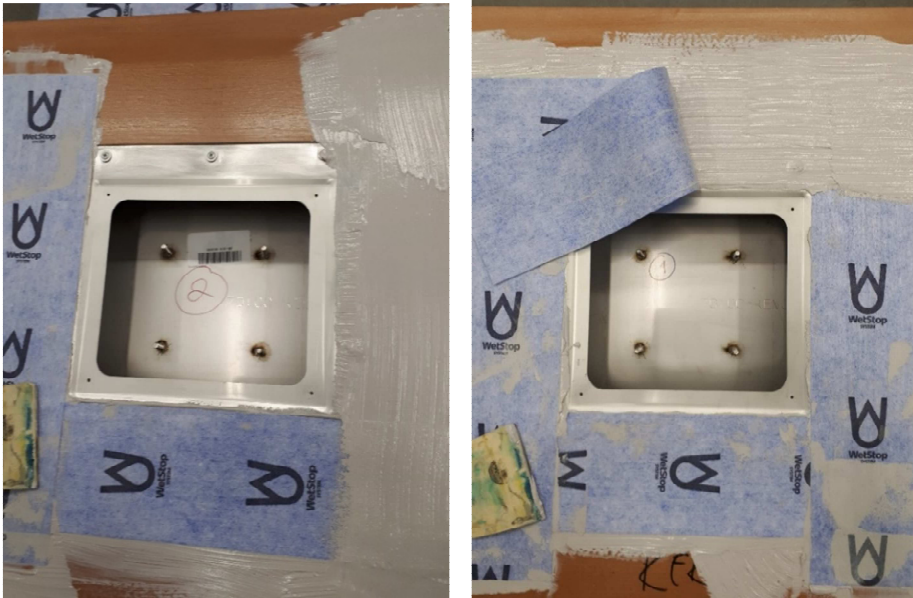
Picture 1-2. Preparation of test specimens WetStop KL-tape.

Edges of the BOX 300 front plate (test done for the whole BOX 300) were first grinded with sandpaper, then cleaned with acetone. Then the Casco primer is applied to the surface, then Casco Aquastop to attach Casco WetStop KL tape. After attaching Casco tape (pictures above) the test sample is applied by two layers of Casco Aquastop.

The BOX300 was installed to the same level with gypsum board. The edges of the BOX300 were grinded with sandpaper, cleaned with acetone and sealed with Casco waterproofing reinforcement tapes (another box with Casco Waterproofing tape and another with Casco Wetstop KL-tape). Two layers of Casco waterproofing membrane were applied. The membrane was applied so that min. 30 mm of front plate surface was covered at each side.

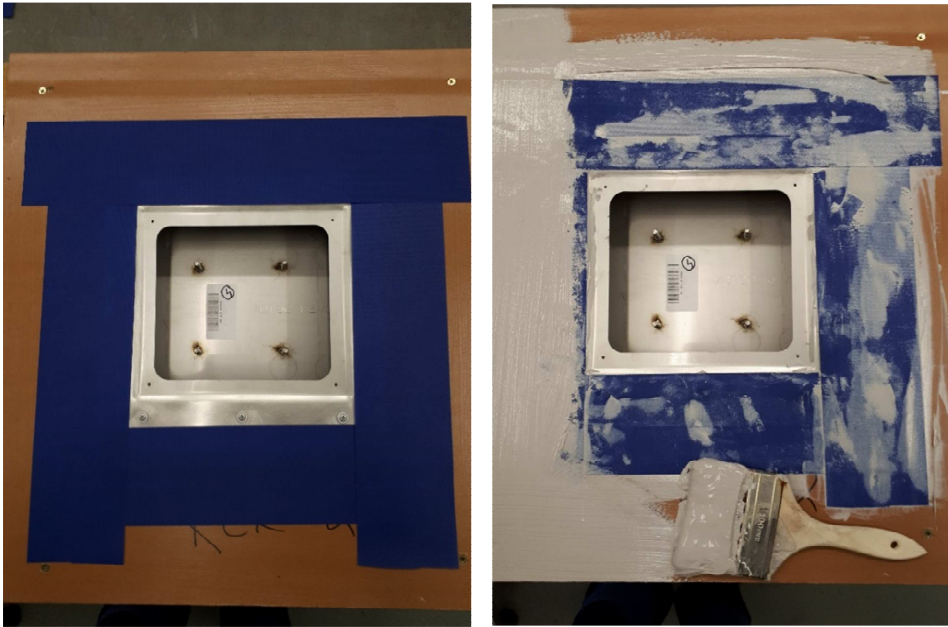
*Picture 3-4. Preparation of test specimens Casco Waterproofing tape*

Edges of the BOX 300 front plate (test done for the whole BOX 300) were first grinded with sandpaper, then cleaned with acetone. Then the Casco primer is applied to the surface, then Casco Aquastop to attach Casco Waterproofing tape. After attaching Casco tape (pictures above) the test sample is applied by two layers of Casco Aquastop.
